Field Service Bulletin CNG Motion Industries Flex Hose Recall

ENP-313, Rev. A July 30, 2015

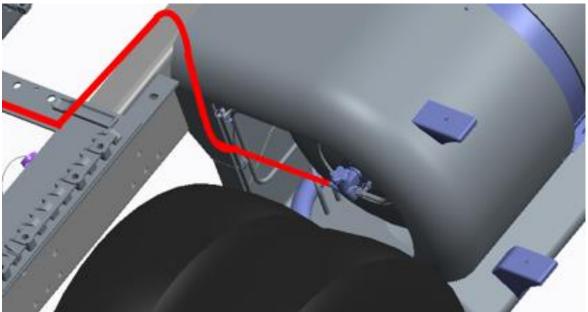
This recall targets hoses Motion Industries stainless steel braided hoses that terminate inside of a side mounted tank enclosure. These parts been observed to experience accelerated corrosion on an exposed area of braid near the collet on the end of the hose.

Figure 1: Side mount tank enclosure with crossover fuel hose highlighted in red.

If your vehicle meets the recall criteria, contact Agility Product Support for replacement. Determine the specs on the hose (1/2-in. or 3/8-in. diameter) and take a photo of the connection at the valve. Measure the length of the hose and take note of fitting sizes to insure the proper equivalent hose is sent. Use the form in Section 5.

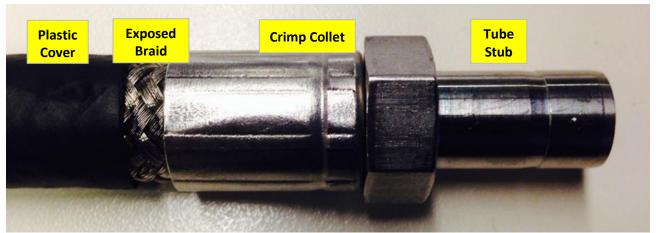
Figure 2: Agility Fuel Systems P/N10300783 Motion industries CNG flexible fuel line.

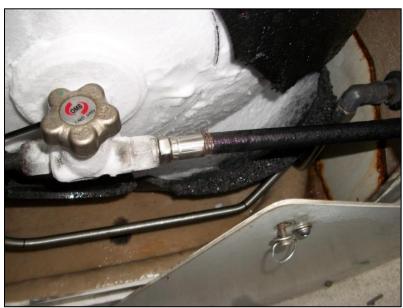
Figure 4 Frost forming near a CNG gas leak. The leak is located at the junction of the braid and fitting ferrule.

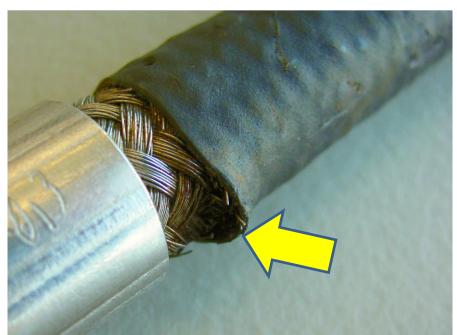
Figure 4 Corrosion at the braid and fitting. The failure location is shown.
